CLOSE CALL CONTINUOUS MINING MACHINE ACCIDENT

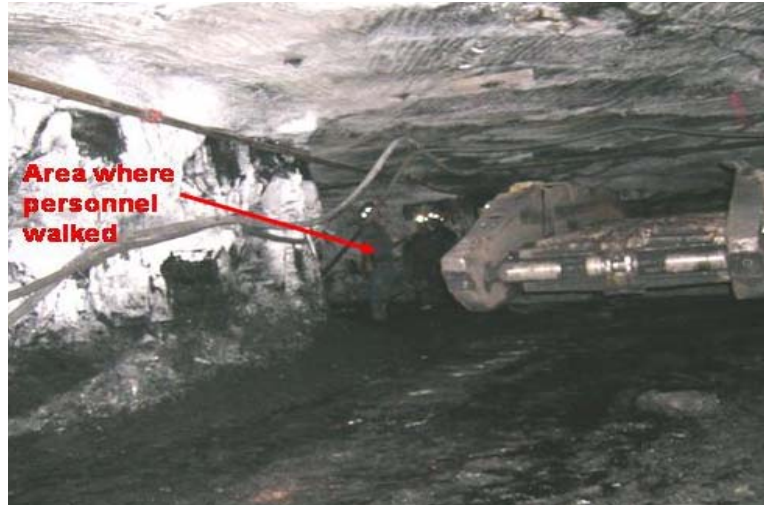
On July 18, 2006, during a maintenance shift, an electrician was injured when the oxygen/acetylene cart he and another miner were pulling was struck by the boom of the continuous mining machine, as another maintenance worker (welder) was attempting to re-position the machine. As the miners pulling the cart passed between the machine and rib, the operator thought they had cleared the boom. He then split the cat-tracks to swing the head into the intersection. This caused the boom to swing toward the rib, striking the cart and throwing the electrician into the rib and a protruding rib pin. He suffered a cracked rib and bruising of his liver, necessitating an overnight stay in the hospital. The other miner was not injured.

1. Ensure everyone is outside the machine turning radius before re-positioning equipment.
2. Avoid pinch points between rib and machinery.
3. Maintain clear visibility with all personnel in the vicinity of moving equipment.
4. Personnel operating machinery should be thoroughly trained and acquainted with its operation, to include safe operating procedures outlined in approved plans.
5. Take extra time if it means avoiding a potentially dangerous condition. The shortest travel distance is not always the safest.
6. Always verify that the operator sees and knows where you are.
7. Consider wearing additional reflective clothing.
